Aero Technical Service Bulletin

Cobra AERO

ATSB0001 B100 propeller hub cracking

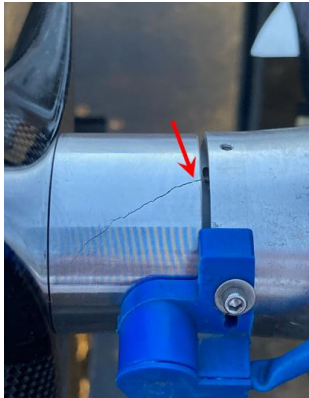
Regarding the B100 propulsion unit, it is requested that all customers implement an inspection of the propeller hub as part of your pre-flight inspection. Cracking of the hub has been noticed on some engines after accruing 150 operational hours. At this time, it is assumed to be an issue only on engines with higher operational hours. This pre-flight inspection should be implemented on all B100 propulsion systems no matter the operational hours.

Make certain the engine is disabled and hand rotate the propeller while inspecting the outer face of the propeller hub. The following image is an example of what to look for. The cracking typically originates on the engine side of the hub (where the red arrow is indicated below) and will progress toward the propeller side.

If cracking is visible on the propeller hub, the propulsion unit should NOT be started or operated until replacement can be coordinated.
