A99H Durability Testing

Rev. 2.3

Chuck Simmons
Sean Hilbert

Cobra Aero, LLC
240 Uran Street
Hillsdale, MI 49242
517-437-9100

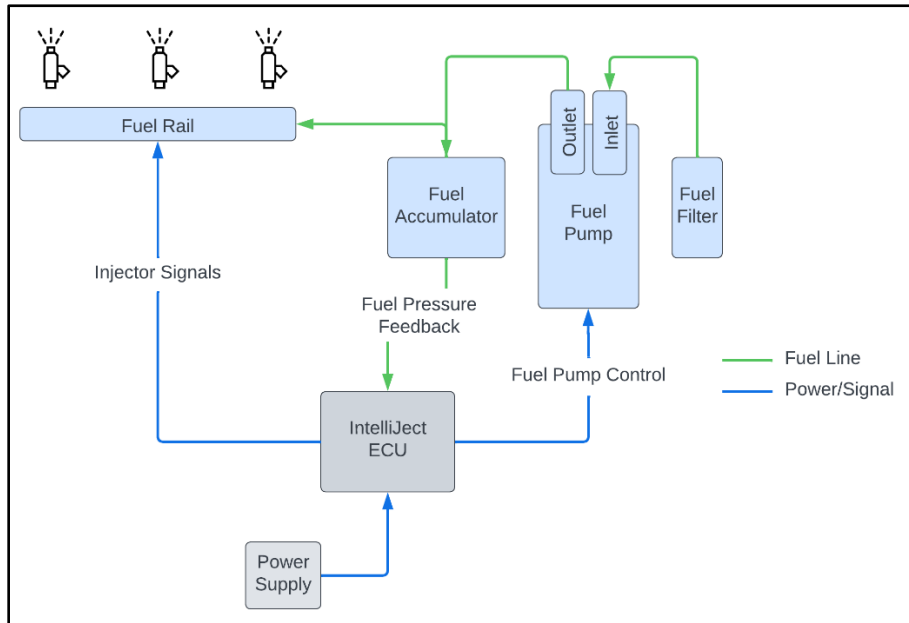
Figure 3: Fuel system schematic.

Engine fuel was USN supplied JP-5 premixed with Amsoil Sabre 2-stroke oil at a 50:1 ratio. Fuel was fed into a 10-micron fuel filter which in turn was fed to the fuel pump attached to the ECU. The fuel pump, which duty-cycles based on pressure feedback from the ECU, fed to the fuel rail on the engine in a dead-head configuration.

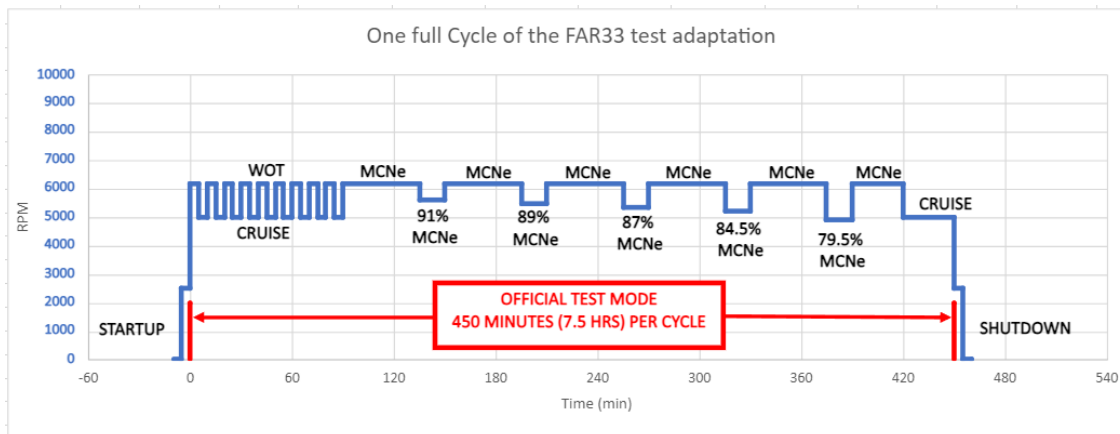
Figure 4. 7.5-hour AMRDEC profile.

To make the endurance intervals manageable in a single workday, the run intervals defined in 33.49 (b) were reorganized into daily run profiles by the US Army AMRDEC (Aviation & Missile Research Development & Engineering Center). This allows one to operate the engine through all the power settings specified in 33.49 (b) in a 7.5-hour cycle, which can be accomplished in one working day including additional time for setup and inspection. A total of 20 cycles is required to reach the full 150-hour requirement, so each of the runs defined in 33.49 (b) is truncated to 1/20th of the interval specified. The accumulated time the engine spends at each power setting is the same as the original profile in 33.49 (b). The 5-minute transitions in Run 1 remain at 5 minutes each (rather than being scaled down) in order to preserve the objective of testing engine transients.

5-minute warm-up and cool-down periods were added at idle (3000 RPM) at the beginning and end of each cycle.

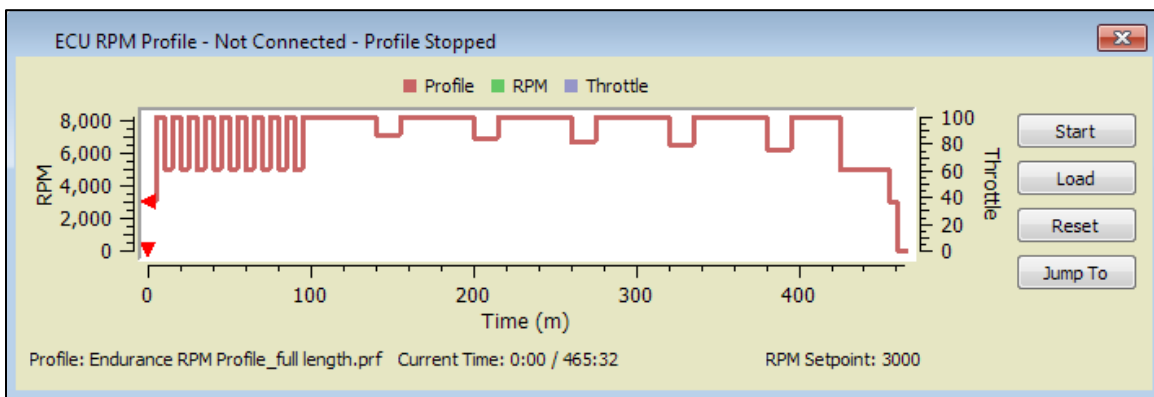
Figure 5: Sample RPM profile for one cycle as shown in IntelliJect Display software.

The test engine maintained the speed references in Table 1 via RPM control feedback which adjusts throttle servo position as required for a particular speed target. The commanded RPMs were generated on an operator's PC which was connected to the ECU via CAN. Once the AMRDEC profile and associated speed references were decided, an RPM profile was loaded and executed so that the PC could control engine RPM throughout each test segment.

For WOT cases (i.e. takeoff speed and MCNe), an arbitrary RPM was selected that was higher than the engine could achieve, thus keeping the throttle commanded to 100%.

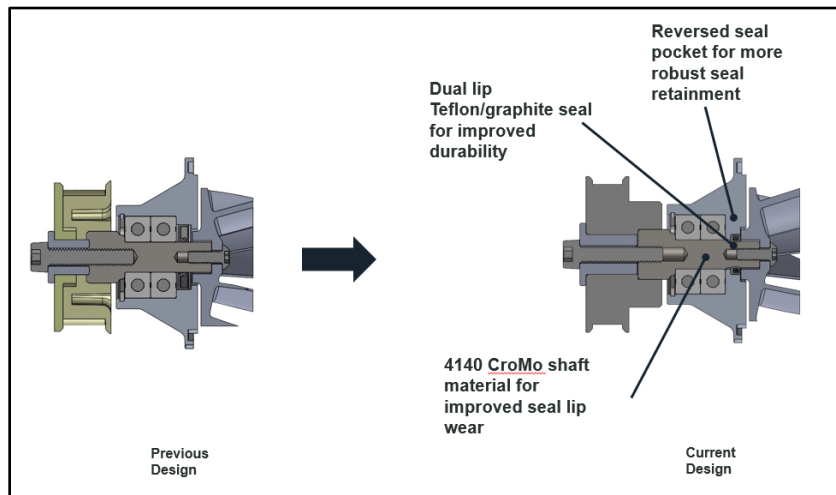
Figure 7. Internal coolant pump updates.

During the course of the test we observed two coolant pump issues. Early in the test, we failed a pump belt, and we observed pump internals coming loose. Figures 7 and 8 illustrate the updates to the system that were made in accordance with these observations.

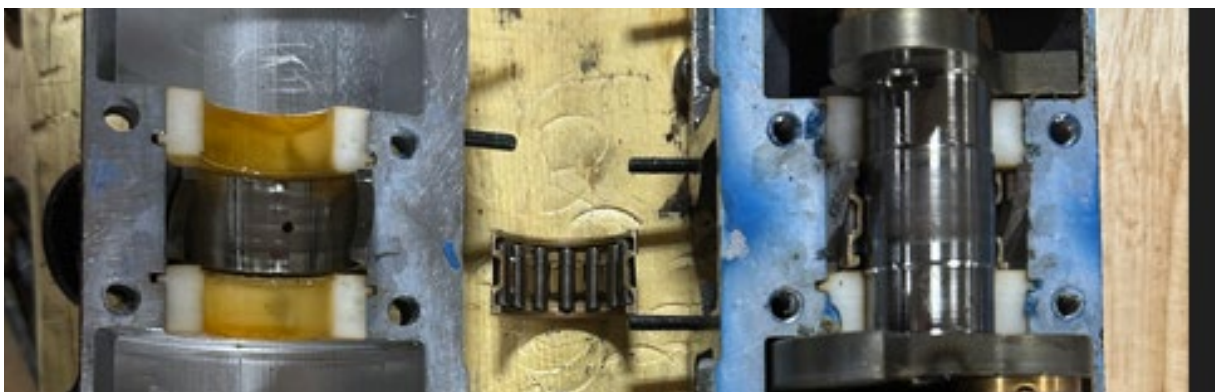
Finally, we looked closely at main bearing wear; especially the non-traditional roller element bearings at the center of the engine. Figure 12 shows good wear characteristics on both race surfaces and on the rollers.

Figure 12. Main bearing wear.

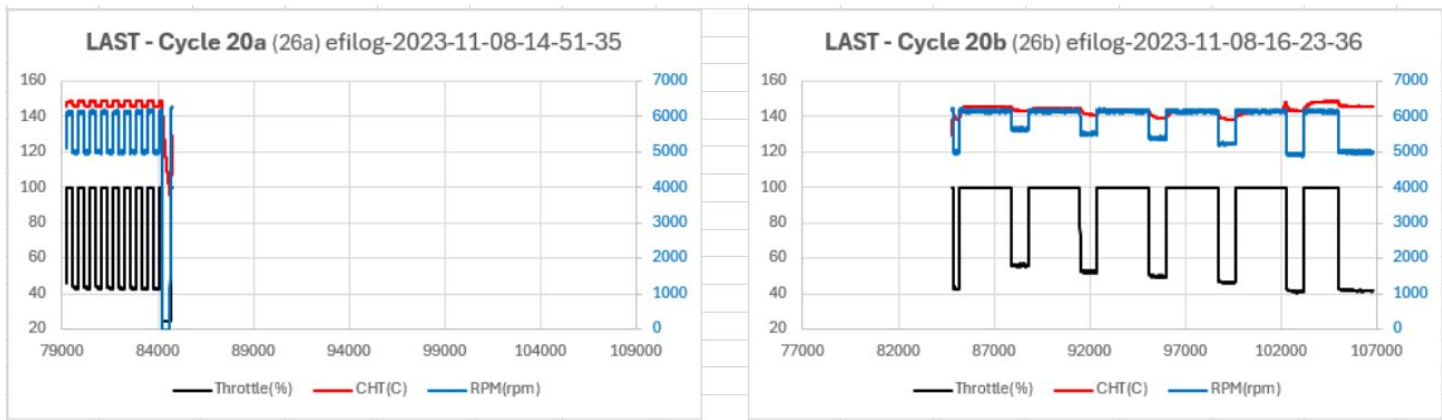
Figure 18A. Cycle 20 trace.
